DEVELOPMENT OF A FAIL SAFE DESIGN OXIDATION
RESISTANT REINFORCED CARBON SYSTEM FOR THE WING
LEADING EDGE OF A SPACE SHUTTLE VEHICLE

PHASE III FINAL REPORT
VOLUME II TECHNICAL

VSD REPORT NO. T143-5R-30008

JUNE 1973

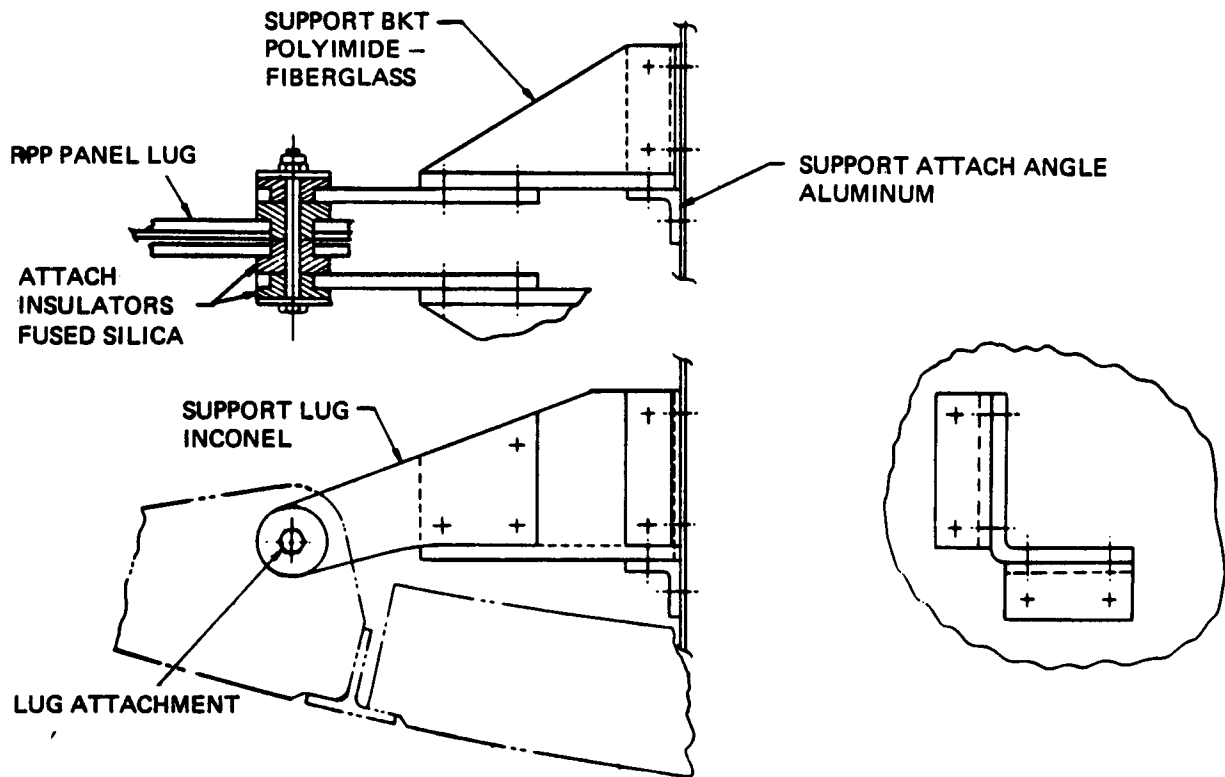
FIGURE 66 EARLY SUPPORT JOINT DESIGN

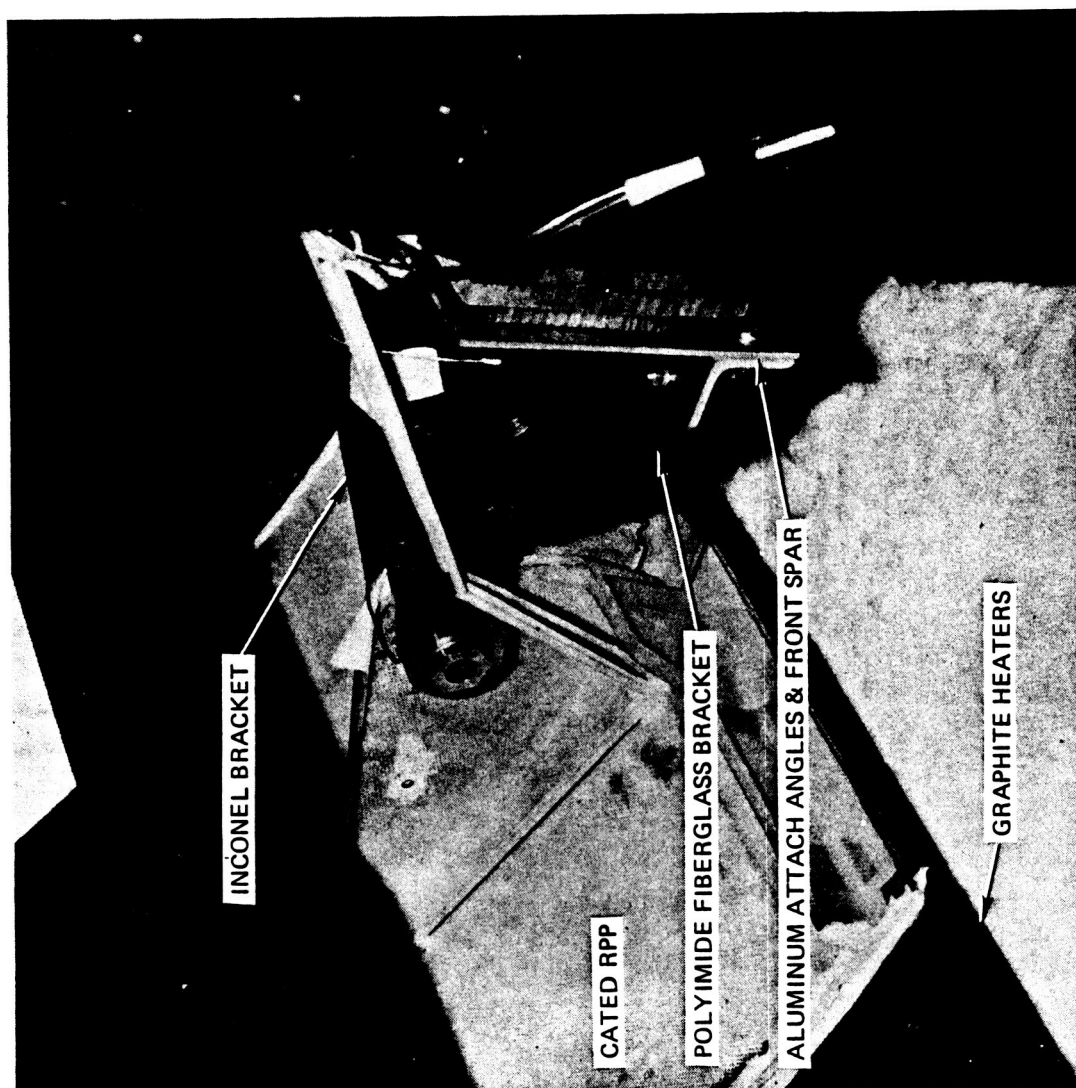
FIGURE 68 INITIAL SUPPORT LUG — COMPONENT TEST

The initial test component is pictured in Figure 68 as installed for test, while the lug bolt design is illustrated in Figure 69. The component was insulated with Dynaflex (12 lb/ft³) insulation^s to simulate flight insulation around the support bracket and lug joint, but Figure 68 does not show this for clarity. In Figure 68 the configuration of the test article is readily seen. It is like that of

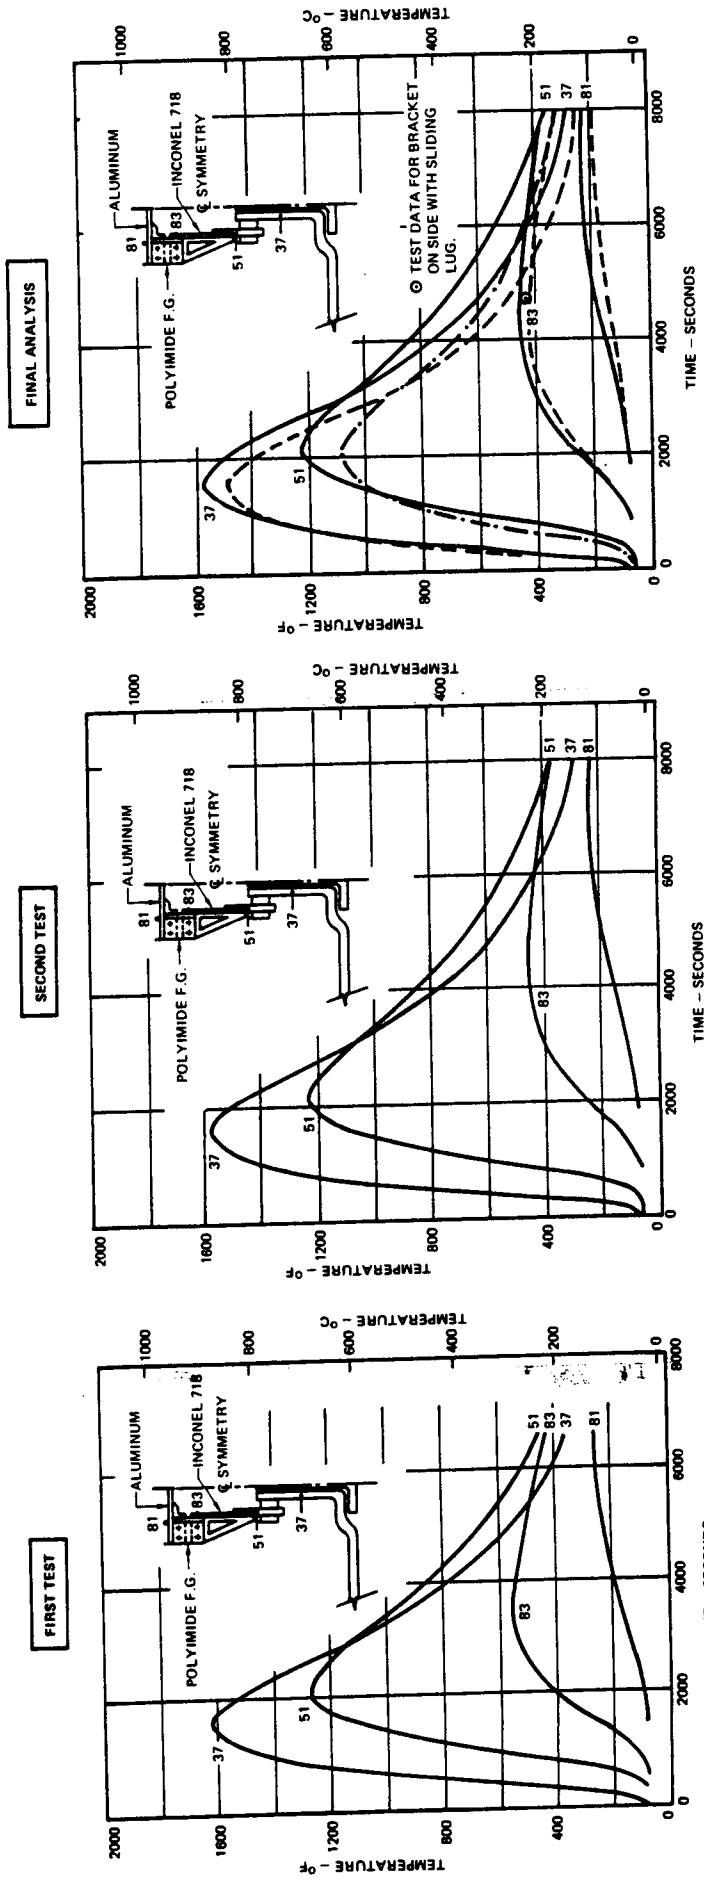
FIGURE 71 TEST RESULTS DESIGN SUPPORT LUG THERMAL TEST

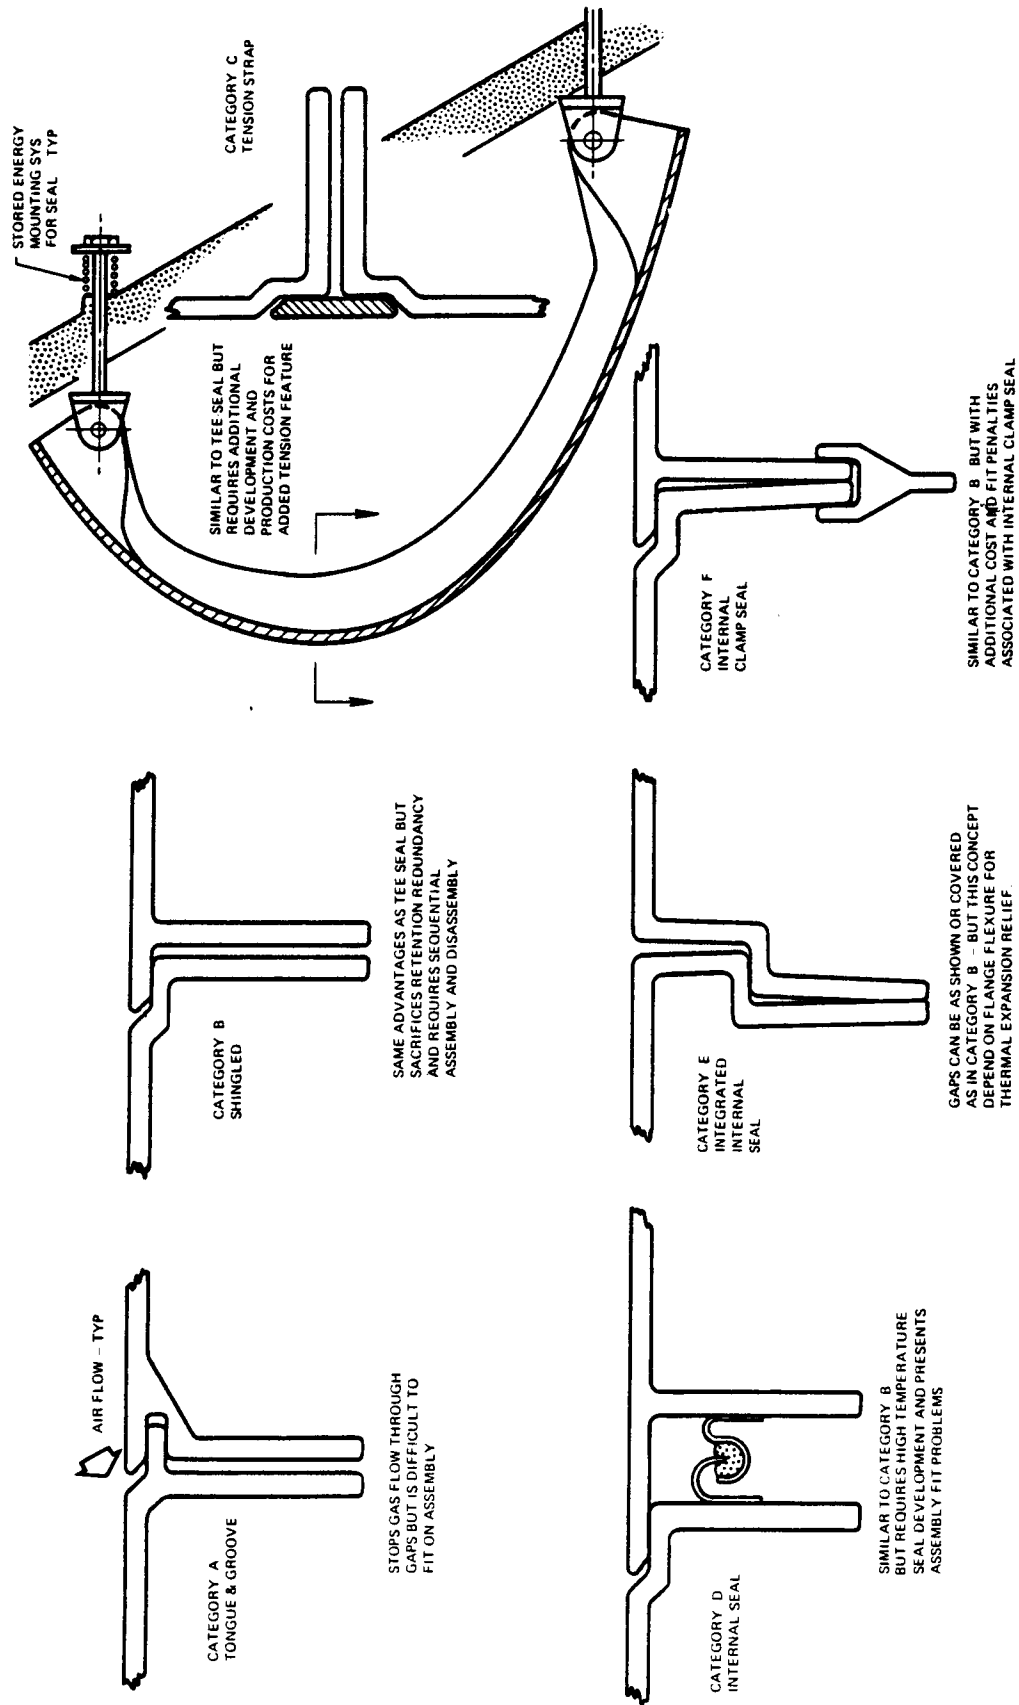
FIGURE 75 TYPICAL EXPANSION JOINT SEAL CONCEPTS

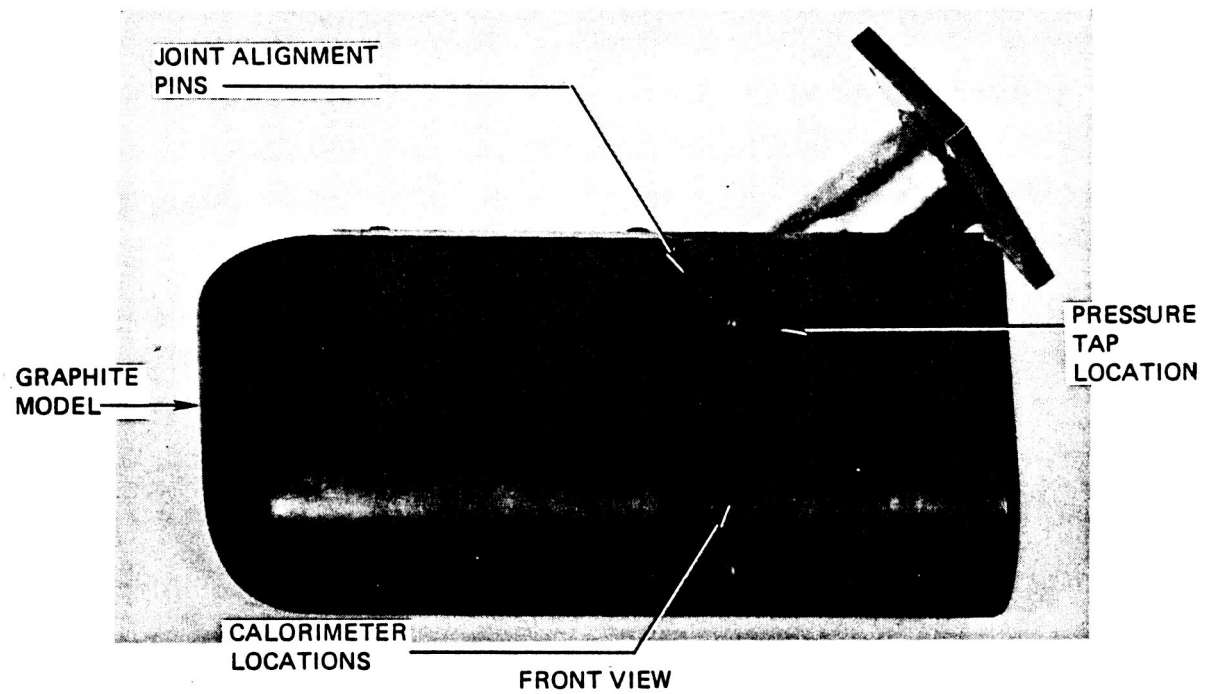
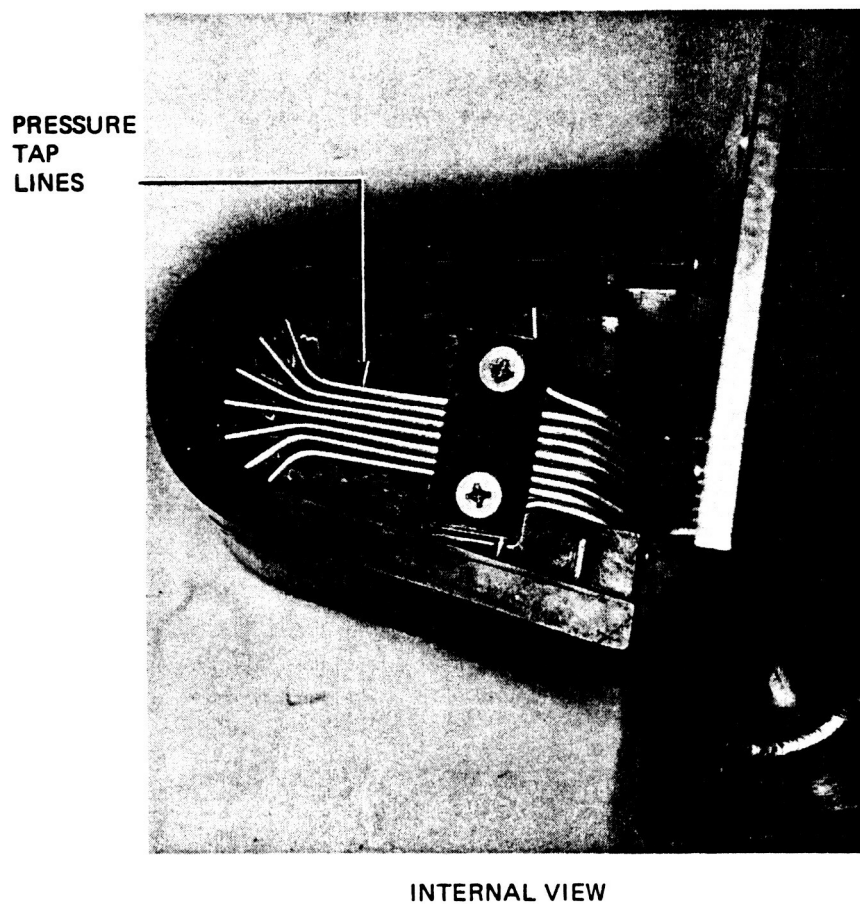
FIGURE 79 CALIBRATION MODEL FOR SEAL STRIP JOINT LEAK TEST

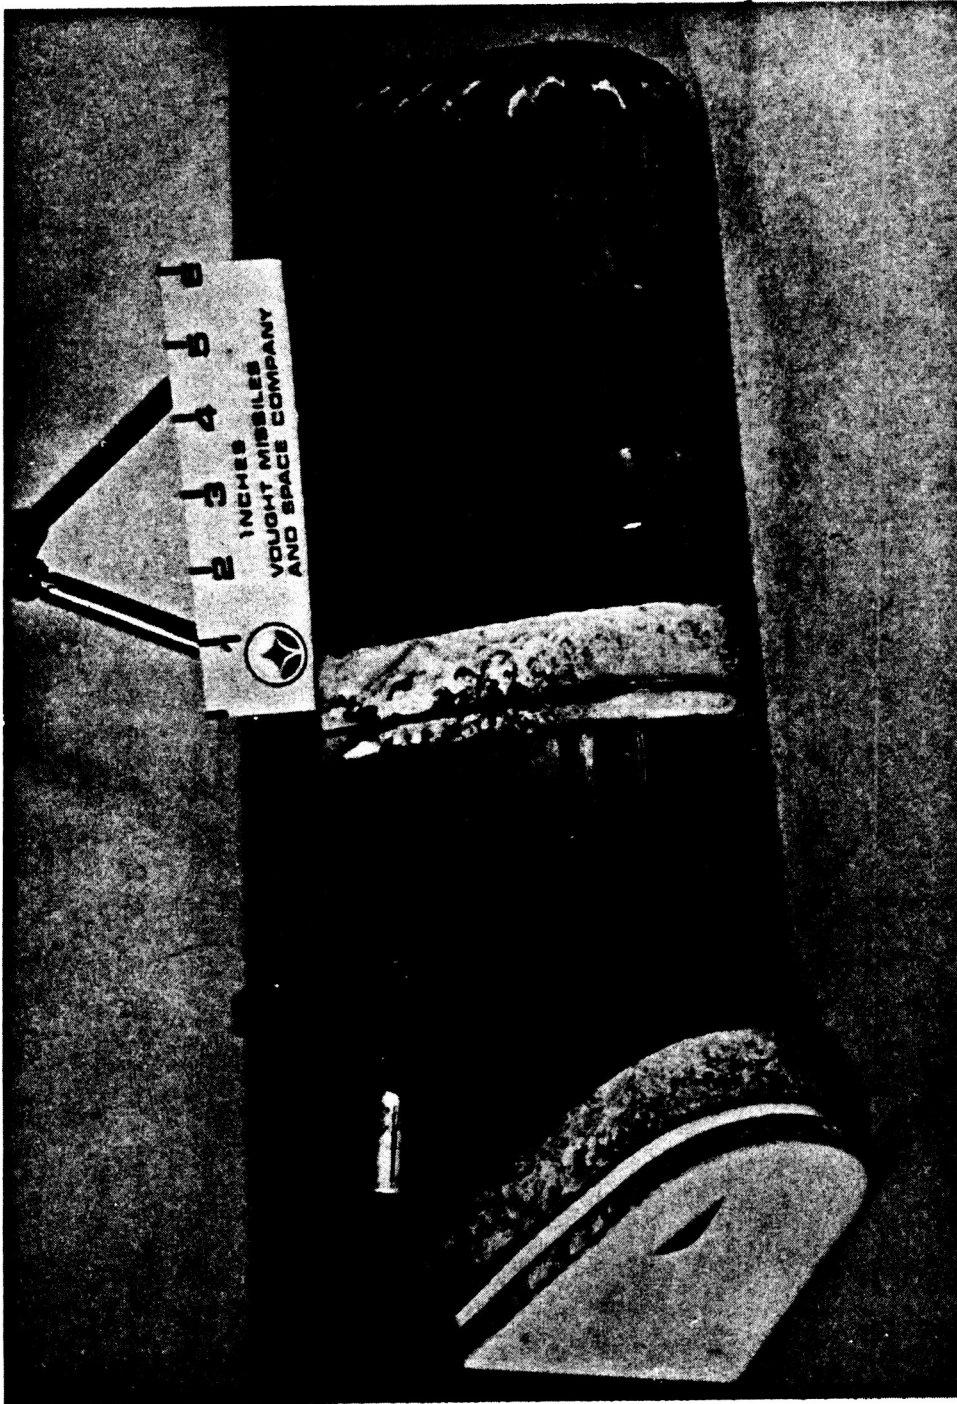
FIGURE 80 TEFLON MODEL FOR SEAL STRIP JOINT LEAK TEST — SHOWN AFTER TEST

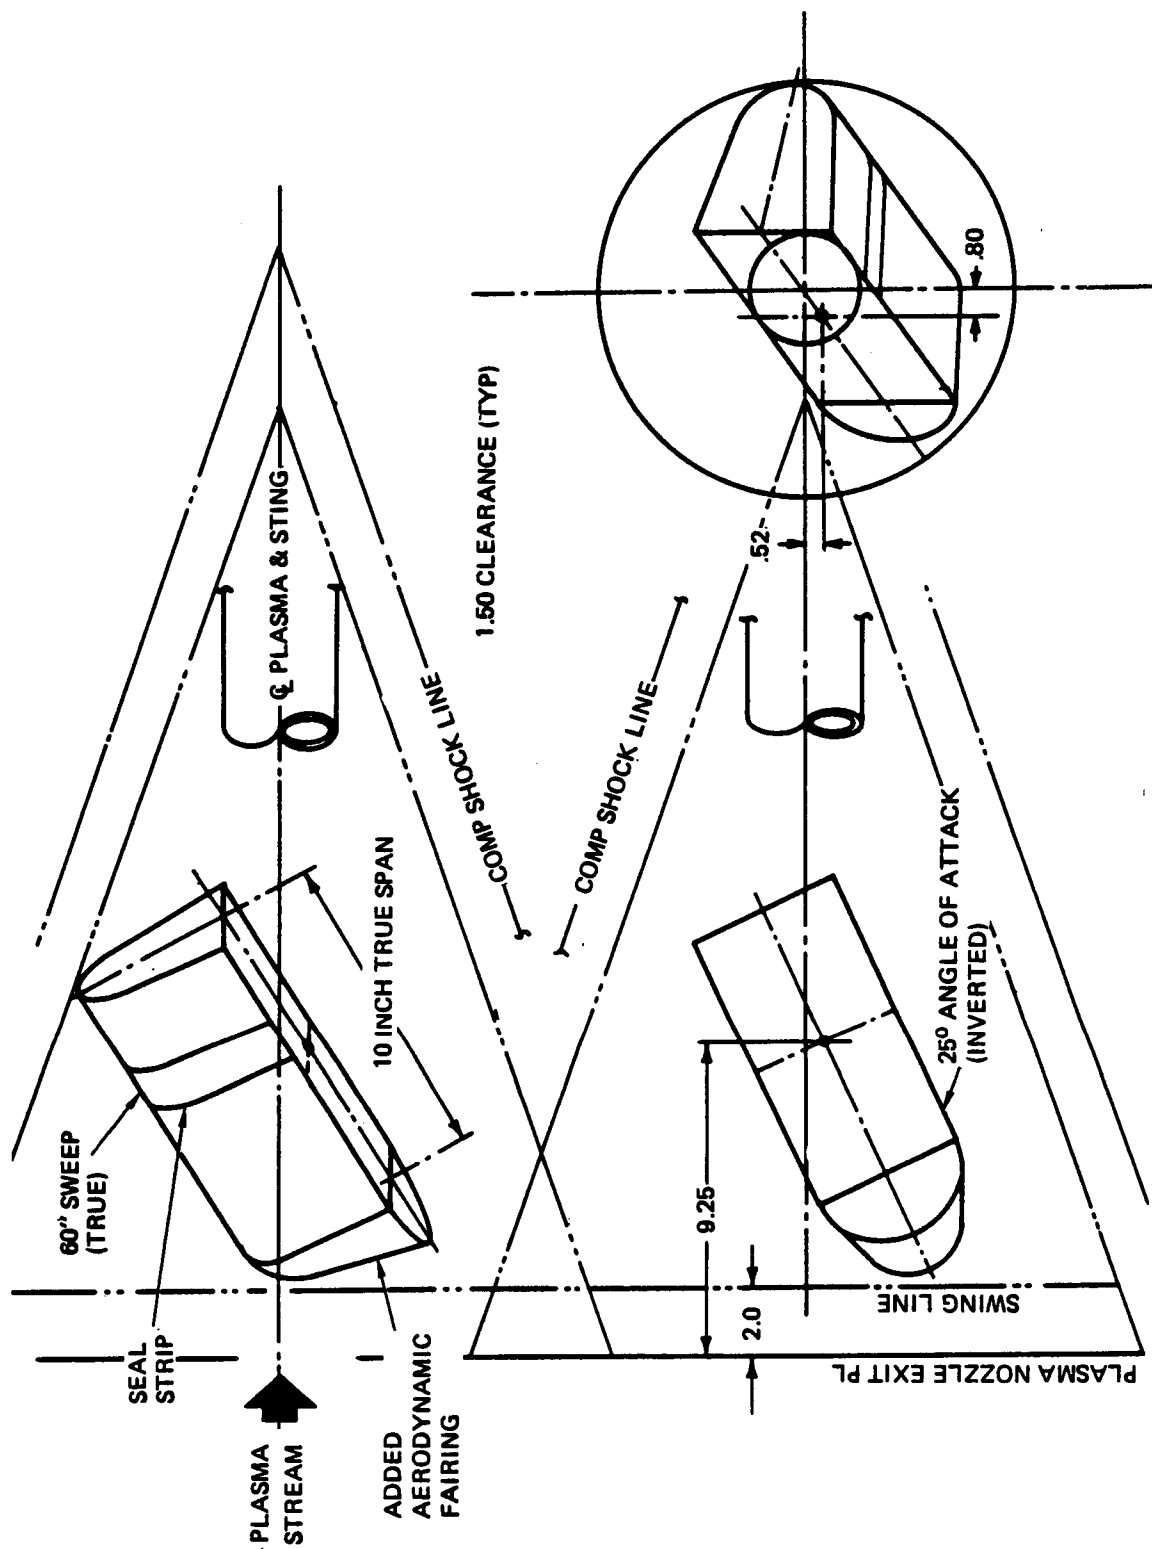
FIGURE 81 SEAL JOINT LEAK TEST MODEL -- LOCATION AND ORIENTATION IN PLASMA ARC FACILITY

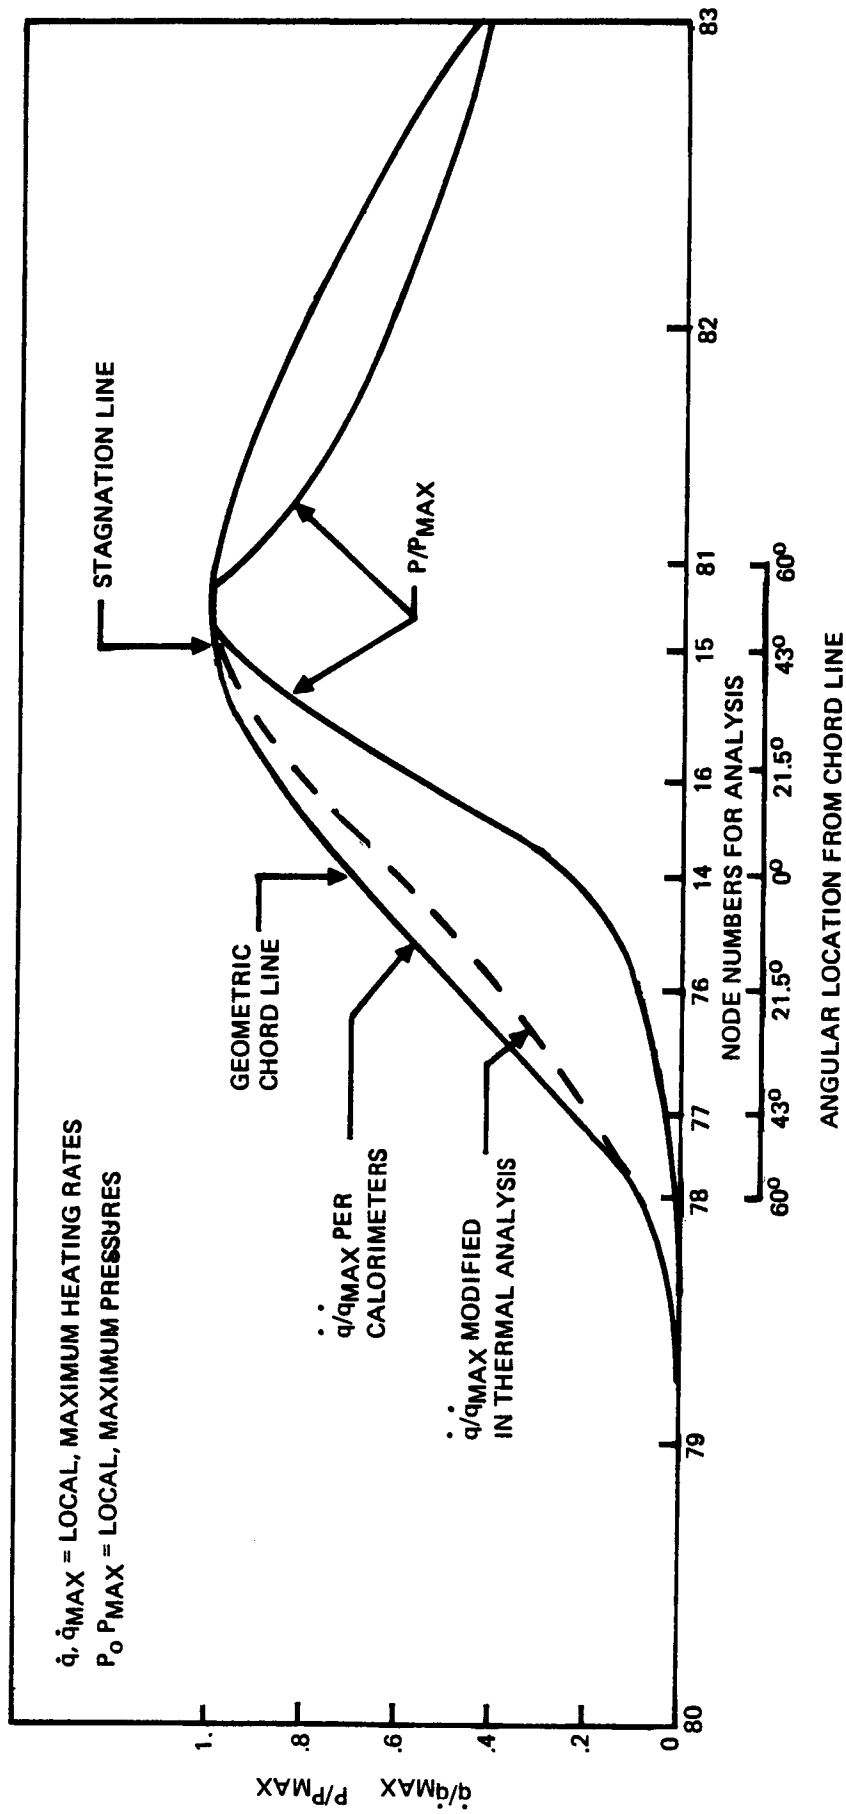
FIGURE 82 CHORDWISE HEATING AND PRESSURE DISTRIBUTIONS FROM CALIBRATION MODEL

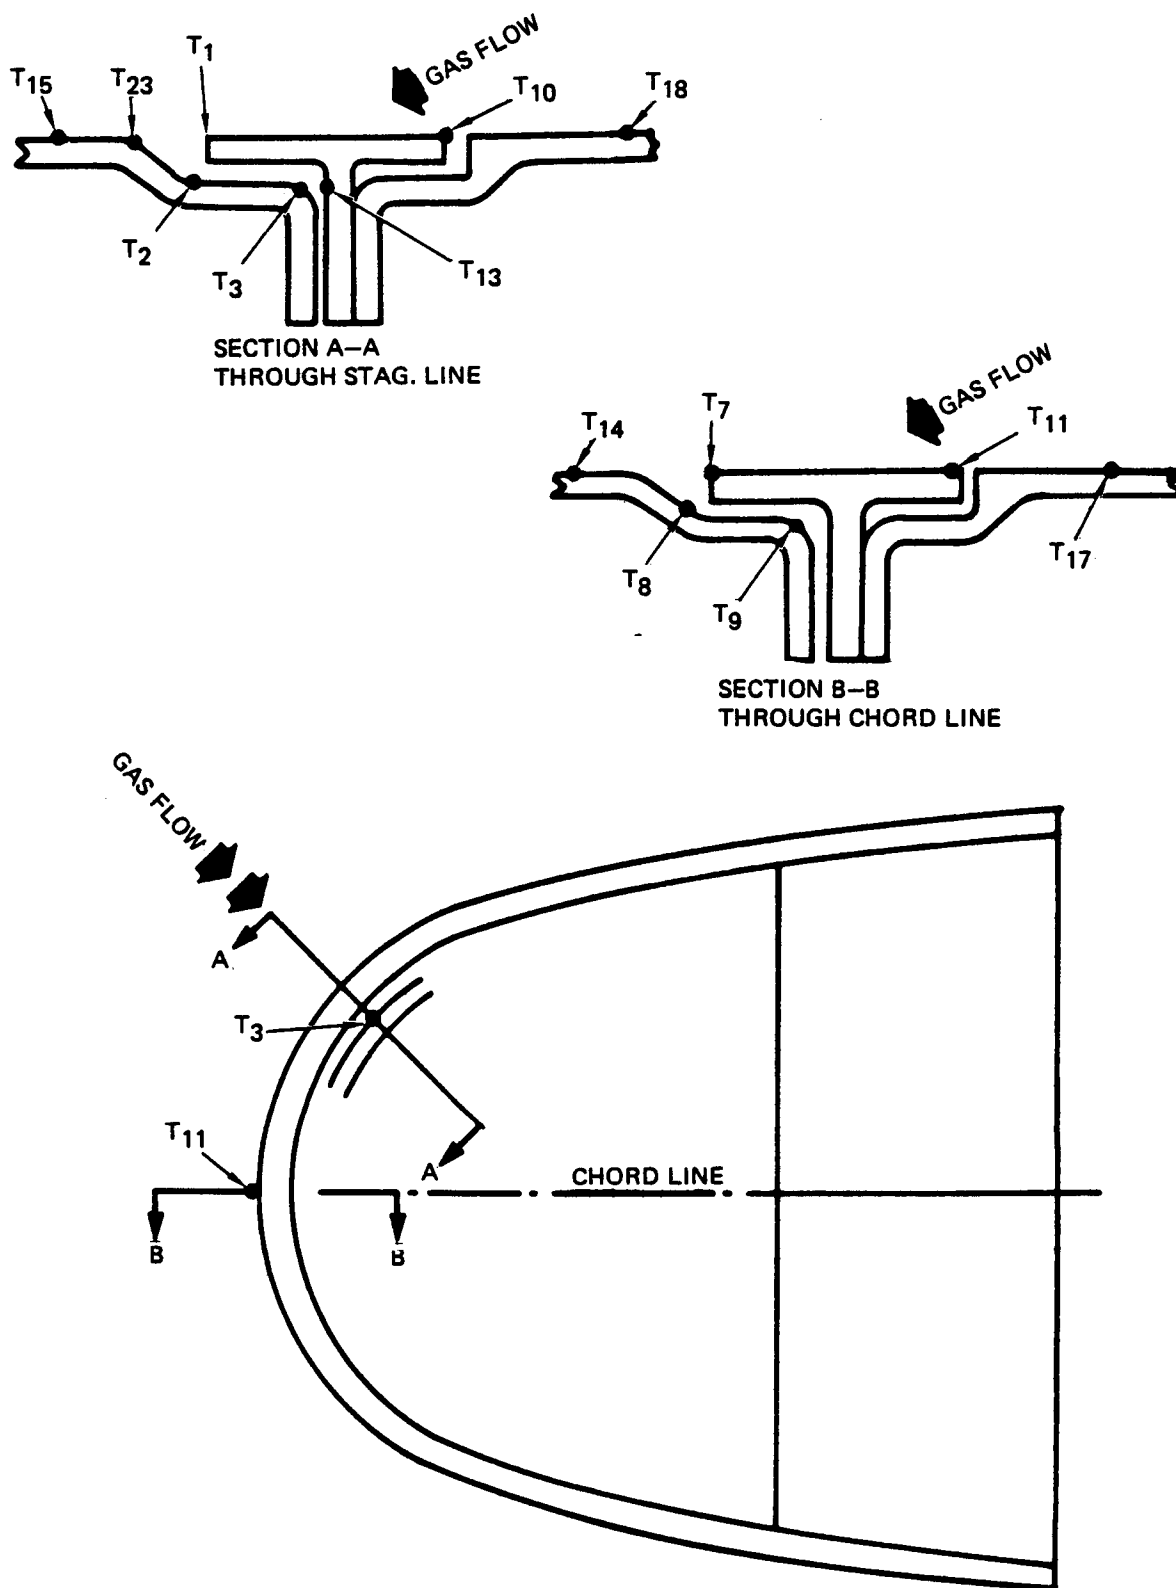
FIGURE 83 THERMAL MODEL WITH SAMPLE TEMPERATURE LOCATIONS

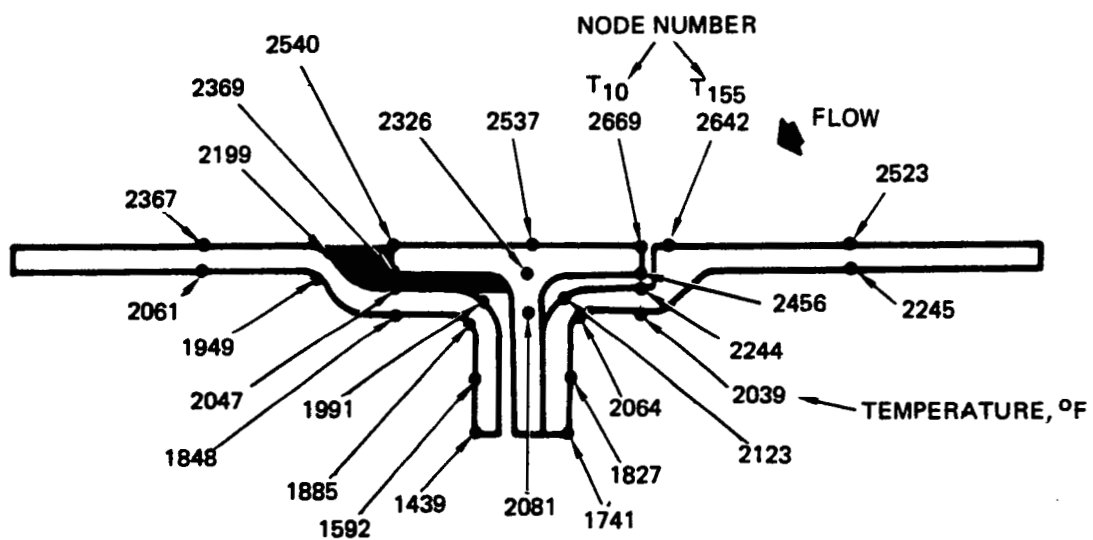
FIGURE 84 DETAILED TEMPERATURES, - 7 ASSEMBLY STAGNATION LINE

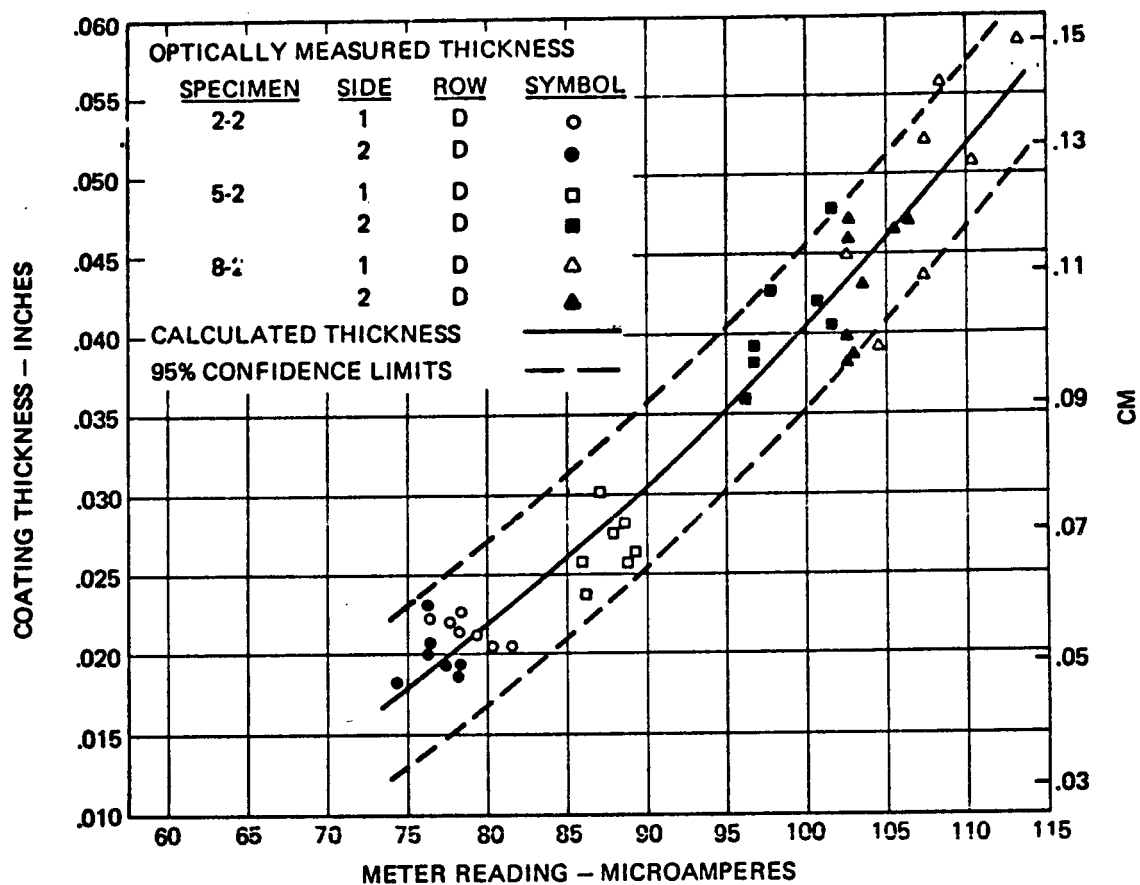
FIGURE 90 EDDY CURRENT STATISTICAL MODEL - 1.6 MHZ EQUIPMENT
